**TABLE ROCK LAKE WATER QUALITY
DECENTRALIZED WASTEWATER
DEMONSTRATION PROJECT**

FINAL TECHNICAL REPORT

Kimberling City Residence Monitoring Results

APPENDIX-I
INDIVIDUAL SITE INSTALLATIONS

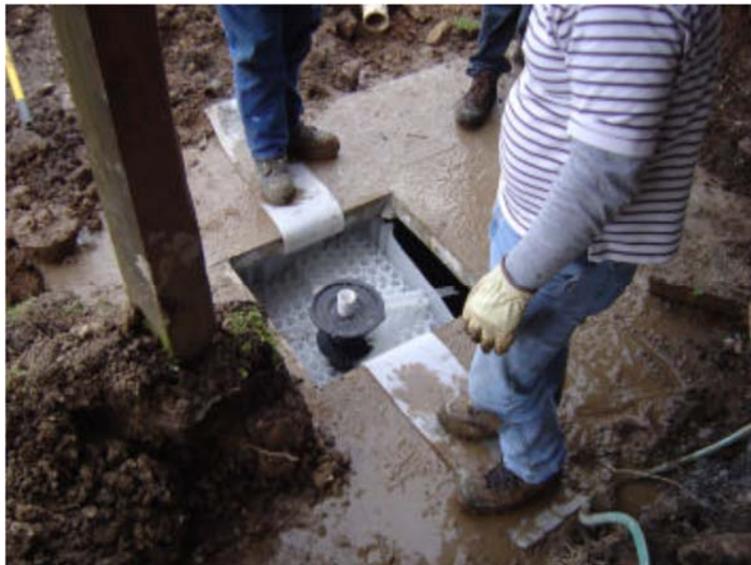
Figure 3.4: RetroFAST unit installation in an existing septic system

A RetroFAST treatment system adapts conventional onsite systems by inserting a RetroFAST unit and aeration blower into an existing watertight and properly sized septic tank (Figure 3.4). This not only enhances wastewater treatment performance but may also be used to remediate failed onsite soil absorption fields or lateral fields. Conventional systems utilize a septic tank to hold solids and a lateral field to disperse the wastewater and provide the majority of treatment. Over time, the lateral field can become clogged with microorganisms called biomatt which find this area conducive for growth. This can eventually prevent wastewater from moving away from the system causing overflow, soggy lawns, plumbing system back-ups and surfacing. Replacement of the soil absorption system is a drastic form of repair can be costly as well as cause damaging to the existing property. RetroFAST wastewater treatment units can be adapted and inserted into the existing tank to promote the growth of aerobic bacteria on the fixed film media in the tank. This helps remove more of the pollutants that originally fed the biomatt that formed the clogging layer in the failed lateral field. RetroFAST systems oxygenated effluent also promotes the development of aerobic bacteria in the soil which digests the existing clog and helps to renovate the failed lateral field.

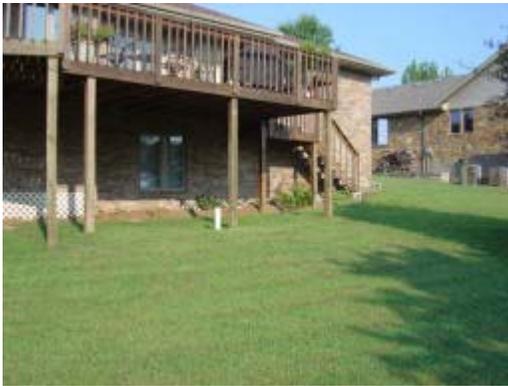
Septic tank and chamber lateral field

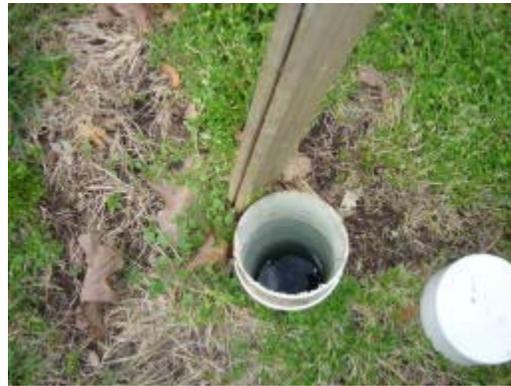
Chamber system full with septic effluent

Reason Chosen: The chamber lateral field had standing and pooling effluent due to biomat build up.

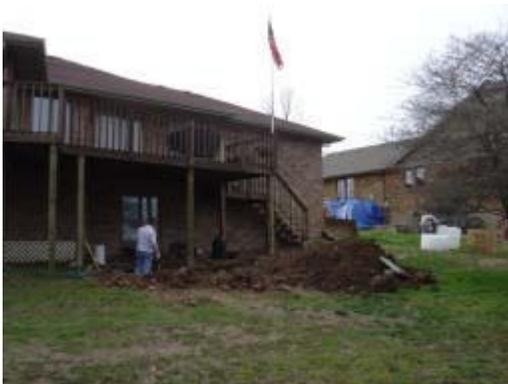
Existing tank uncovered

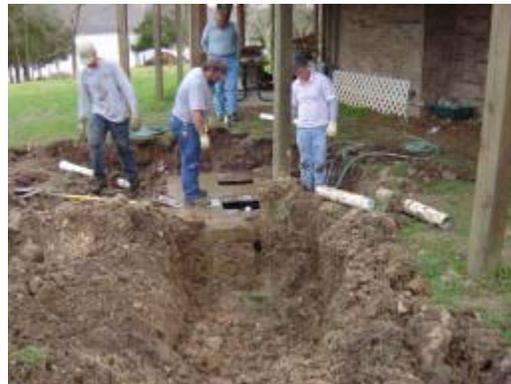
Square access hole cut in tank lid

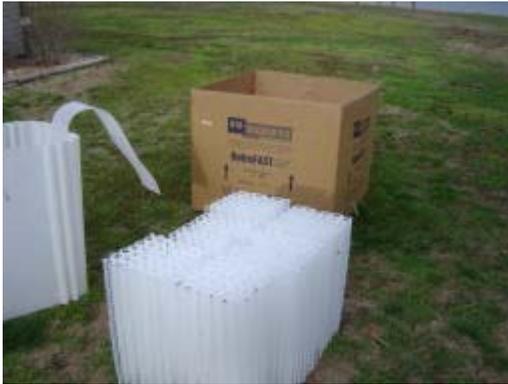
RetroFAST is easy to ship to site

The Bio-Microbics RetroFAST unit was installed in the existing concrete watertight septic tank. Beginning in November 2005, monitoring staff measured water levels in a vertical PVC pipe inserted through the soil into a dispersal pipe chamber. Standing water depths of up to 0.9 inches were measured in the spring of 2006 during a period of heavy rainfall (Figure 5.41). No standing water was detected in subsequent measurements which included periods of comparable rainfall. These data indicated favorable flow distribution in the lateral field compared to initial conditions. The improvement may have been attributed to reduced biomass buildup in the drainfield following the RetroFAST unit installation. The RetroFAST unit's high-quality, aerobic effluent was favorable for minimal biomass production in the drainfield.

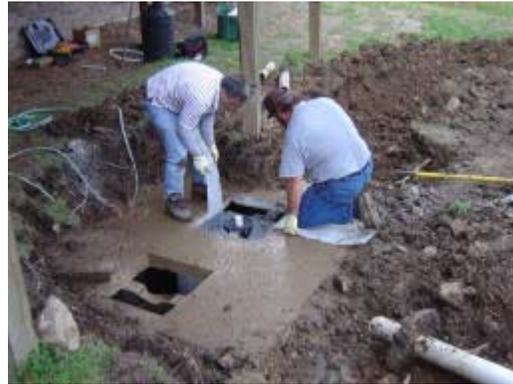
RetroFAST lowered in the tank.

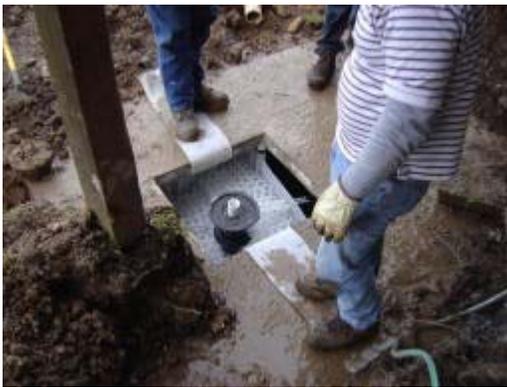
Plastic wings hold system in place.
